**Flood Control Project Maintenance
Levee Inspections**

Fall 2018 Levee Maintenance Deficiency Summary Report

Sacramento River Basin

Reclamation District No. 0551 Pearson

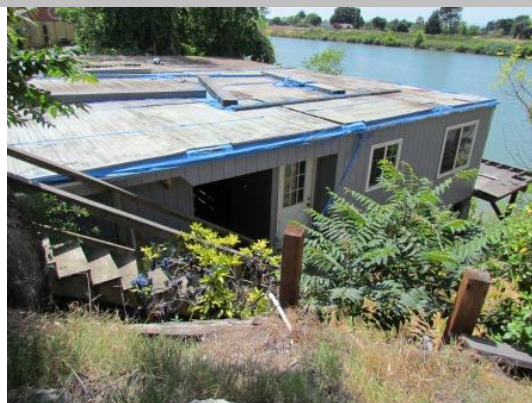
Photo 1 of 3 : FA_2018_RD0551_175_21_20180925_00007.jpg

LM Start	0.49	Rating **	M	Issue No.	21
LM End	0.49	Issue Type +	En	Location *	WS
Category	Earthen Levee			GPS Latitude/Longitude	
				Start	End
Item	Encroachments			38.331063 °	38.331063 °
				-121.570634 °	-121.570634 °
DWR ID	DWR_RD0551_01_s_2014_21				
Comment Code					
BU : Building					
Inspector Comment					
11750 River Road - The new land owner is working with the LMA trying to get CVFPB Permits for this project. No other work at this site. Waiting to hear from Enforcements.

Building and steps waterward. Photo taken 01-04-2014.

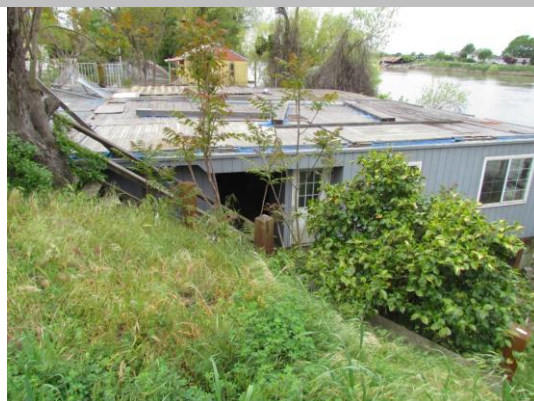
Photo 3 of 3 : FA_2018_RD0551_175_21_20180925_00009.jpg

LM Start	0.49	Rating **	M	Issue No.	21 (cont)	
LM End	0.49	Issue Type +	En	Location *	WS	
Category	Earthen Levee			GPS Latitude/Longitude		
				Start		End
Item	Encroachments			38.331063 °		38.331063 °
				-121.570634 °		-121.570634 °
DWR ID	DWR_RD0551_01_s_2014_21					
Comment Code						
BU : Building						
Inspector Comment						
11750 River Road - The new land owner is working with the LMA trying to get CVFPB Permits for this project. No other work at this site. Waiting to hear from Enforcements.

Photo taken 4-06-2017 no change. No work done, no permit issued.

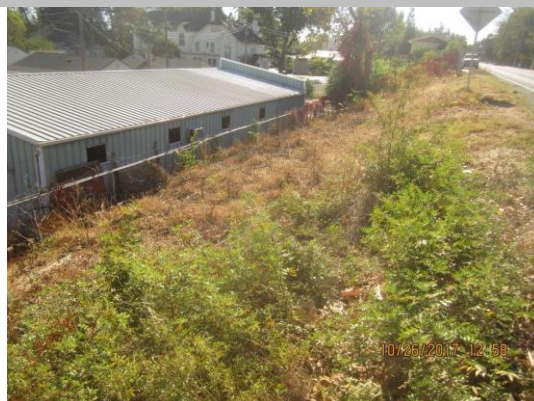
Photo 1 of 2 : FA_2018_RD0551_175_19_20180925_00005.jpg

LM Start	0.49	Rating **	A/W	Issue No.	19
LM End	0.49	Issue Type +	Ma	Location *	LS
Category	Earthen Levee			GPS Latitude/Longitude	
				Start	End
Item	Vegetation			38.331078 °	38.331078 °
				-121.570703 °	-121.570703 °
DWR ID	DWR_RD0551_01_f_2017_19				
Comment Code					
V2 : Remove the wild growth other than native grasses from the levee slopes.					
Inspector Comment					
Dense landside vegetation has been cleared and should be maintained.

Tall landside vegetation has been cleared.

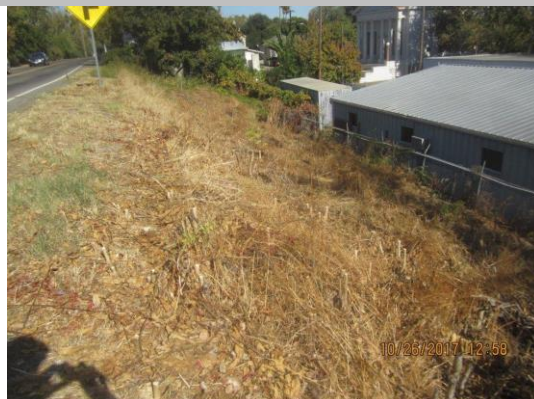
Photo 2 of 2 : FA_2018_RD0551_175_19_20180925_00006.jpg

Tall landside vegetation has been cleared.

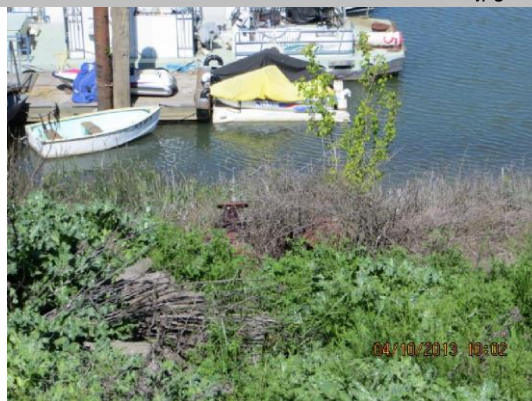
Photo 1 of 3 : UCIP_FA_2018_11726_19165.jpg

LM Start	0.71	Rating **	M	Issue No.	61	
LM End	0.71	Issue Type +	En	Location *		
Category	Supplemental			GPS Latitude/Longitude		
				Start	End	
Item	DWR UCIP Field Study			38.328401 °	38.328401 °	
				-121.572954 °	-121.572954 °	
DWR ID	21985					
Comment Code						
Inspector Comment						
FS_ID:11726 DS_ID:21985 EP_NO: 6220 Repair Type: Non-Urgent Crossing Status: Found UCIP Comments: Pipe abandoned and should be removed. FIELD_STRUCT_DESC: 8-inch coated steel irrigation pipe through the levee, 6.1 feet below the crown. Pump on the waterside (WS) with slide gate and air vent. (Permit No. 6220, 1968 - Robert U. Grant). [Additional Reference(s): DWR Levee Log, 2005]. FS Date: 4/10/2013

Abandoned pump covered in vegetation on WS slope.

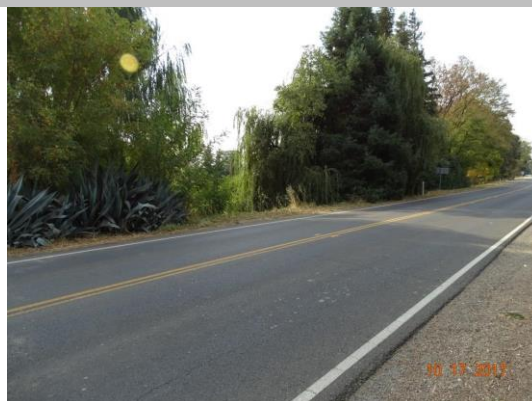
Photo 1 of 1 : FA_2018_RD0551_175_44_20180925_00067.jpg

LM Start	0.75	Rating **	M	Issue No.	44
LM End	0.75	Issue Type +	En	Location *	LS
Category	Earthen Levee			GPS Latitude/Longitude	
				Start	End
Item	Vegetation			38.327959 °	38.327959 °
				-121.573344 °	-121.573344 °
DWR ID	DWR_RD0551_01_f_2017_44				
Comment Code					
V6 : Landscaping					
Inspector Comment					
Landscaping should be maintained to allow inspection and access to landside slope and toe. Large cactus should be removed.

Landscaping should be maintained to allow inspection and access to landside slope and toe.

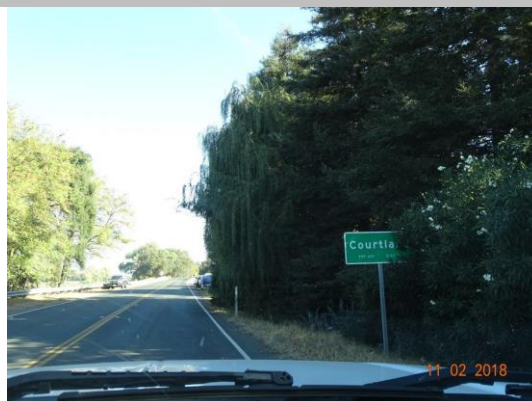
Photo 1 of 1 : FA_2018_RD0551_175_57_20181102_00113.jpg

LM Start	0.76	Rating **	U	Issue No.	57
LM End	0.76	Issue Type +	En	Location *	LS
Category	Earthen Levee			GPS Latitude/Longitude	
				Start	End
Item	Vegetation			38.327783 °	38.327783 °
				-121.573362 °	-121.573362 °
DWR ID	DWR_RD0551_01_f_2018_57				
Comment Code					
V6 : Landscaping					
Inspector Comment

View looking upstream at landscaping on the land side slope (November 2018).

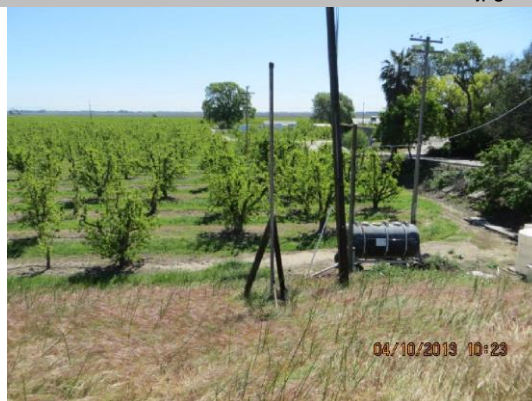
Photo 2 of 3 : UCIP_FA_2018_11727_19167.jpg

Comment Code						
Inspector Comment						
FS_ID:11727 DS_ID:21986 EP_NO: 701 Repair Type: Non-Urgent Crossing Status: Found UCIP Comments: Pipe appears abandoned and should be done so properly. Good candidate for video inspection. FIELD_STRUCT_DESC: 14-inch steel irrigation pipe through the levee, 7.2 feet below the crown. Pump in pump house on the waterside (WS) slope. Service pole on the landside (LS) slope. 1-inch galvanized filler pipe, and a 2-inch electrical conduit at the same location. (Permit No. 701, 1937 - American Trust Company). [Additional Reference(s): DWR Levee Log, 2005. USACE Sacramento O&M Manual 111, May 1959, (RM 33.91)]. FS Date: 4/10/2013

Pipe and JP visible on LS toe.

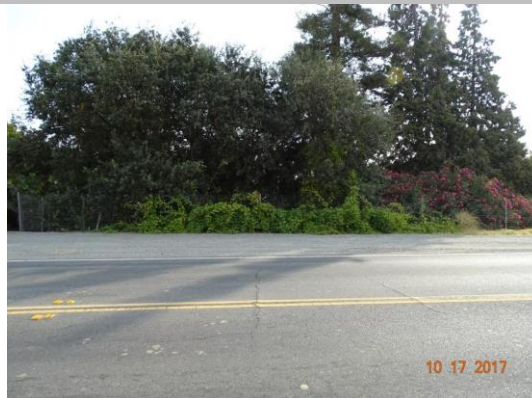
Photo 1 of 1 : FA_2018_RD0551_175_46_20180925_00069.jpg

LM Start	1.36	Rating **	M	Issue No.	46
LM End	1.36	Issue Type +	En	Location *	LS
Category	Earthen Levee			GPS Latitude/Longitude	
				Start	End
Item	Vegetation			38.319621 °	38.319621 °
				-121.576531 °	-121.576531 °
DWR ID	DWR_RD0551_01_f_2017_46				
Comment Code					
V6 : Landscaping					
Inspector Comment					
Landscaping should be maintained to allow inspection and access to lanside slope and toe.

Landscaping should be maintained to allow inspection and access to landside slope and toe.

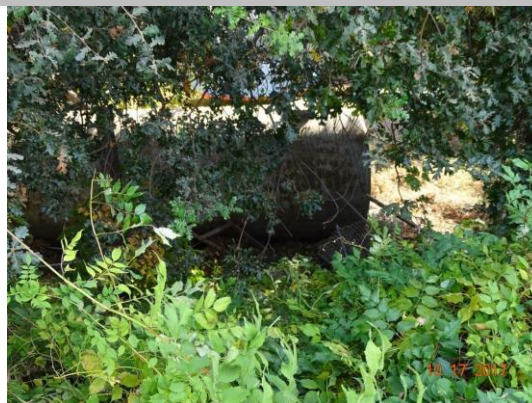
Photo 1 of 1 : FA_2018_RD0551_175_45_20180925_00068.jpg

LM Start	1.36	Rating **	M	Issue No.	45
LM End	1.36	Issue Type +	En	Location *	LS
Category	Earthen Levee			GPS Latitude/Longitude	
				Start	End
Item	Encroachments			38.319620 °	38.319620 °
				-121.576531 °	-121.576531 °
DWR ID	DWR_RD0551_01_f_2017_45				
Comment Code					
TA : Tank					
Inspector Comment					
LMA will talk to owner about moving the tank.

Tank at landside toe should be removed to allow inspection and access.

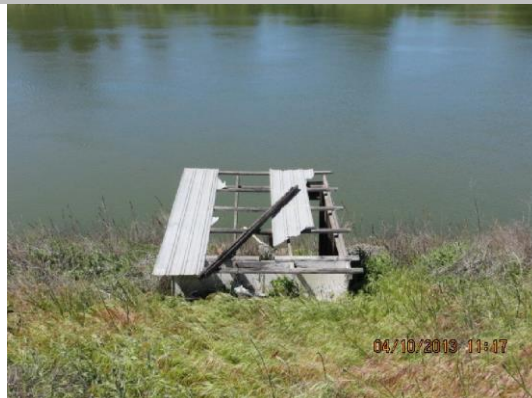
Photo 1 of 3 : UCIP_FA_2018_26874_49596.jpg

Comment Code					
Inspector Comment					
FS_ID:26874 DS_ID:21990 EP_NO: 11145 Repair Type: Non-Urgent Crossing Status: Found UCIP Comments: Based on District notes from January 14, 2014, pump discharge pipe has been repaired. Pipe failing on LS slope causing erosion along pipe alignment. Pipe debris on both slopes should be removed as well.: As of 12/13/2013 District President noted that the landowner had made repairs to the LS slope leaks.: As of 12/17/2013 District submitted letter to landowner explaining UCIP report details including photos of the pipe problems FIELD_STRUCT_DESC: 10-inch irrigation pipe of an unknown material through the levee, 4.7 feet below the crown. Pump in a 7-foot by 9-foot concrete pump house on the waterside (WS) slope. 36-inch concrete riser on the landside (LS) toe. 1-inch electrical conduit at the same location. Service pole at the LS toe. (Automatic Board Order (ABO) issued as Permit No. 11145, 1975 - Horace D. and Lucile Towne). [Additional Reference(s): DWR Levee Log, 2005. USACE Sacramento O&M Manual 111, May 1959, (RM 33.02), listed as an 8-inch pipe]. FS Date: 1/15/2014

Pumphouse on WS slope.

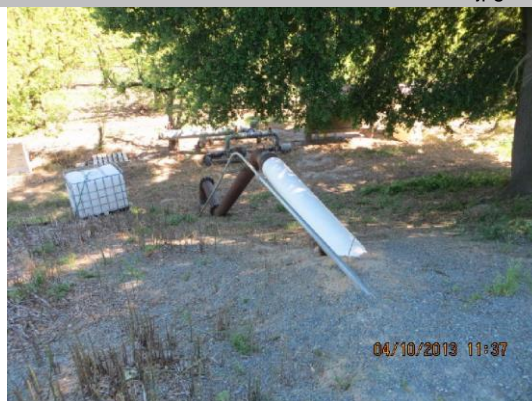
Photo 2 of 3 : UCIP_FA_2018_11763_19221.jpg

Comment Code						
Inspector Comment						
FS_ID:11763 DS_ID:21991 EP_NO: 6551 Repair Type: Non-Urgent Crossing Status: Found UCIP Comments: Rodent activity undermining pipe on LS slope. FIELD_STRUCT_DESC: 1 of 2: 14-inch polyvinyl chloride (PVC) wrapped steel irrigation pipe through the levee, 3 feet below the crown. Butterfly valve on the waterside (WS) shoulder. 2-inch galvanized electrical conduit at the same location. Pump on pile structure on the WS toe. Pressure booster and pump on the landside (LS) toe. (Permit No. 6551, 1969 - John D. Wheeler). [Additional Reference(s): DWR Levee Log, 2005. USACE Sacramento O&M Manual 111, May 1959, (RM 32.78)]. FS Date: 4/10/2013

Pipe, electrical conduit, and booster pump on LS toe.

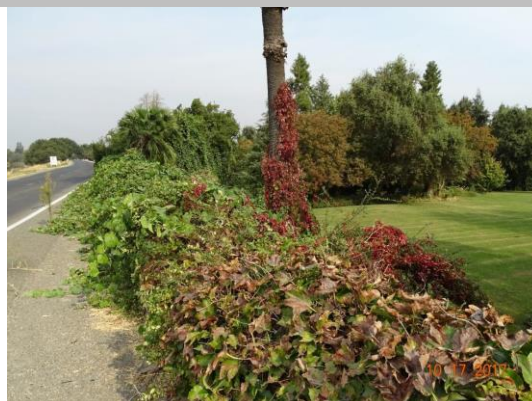
Photo 1 of 1 : FA_2018_RD0551_175_47_20180925_00070.jpg

LM Start	2.29	Rating **	U	Issue No.	47
LM End	2.29	Issue Type +	En	Location *	LS
Category	Earthen Levee			GPS Latitude/Longitude	
				Start	End
Item	Vegetation			38.306755 °	38.306755 °
				-121.572916 °	-121.572916 °
DWR ID	DWR_RD0551_01_f_2017_47				
Comment Code					
V6 : Landscaping					
Inspector Comment					
Landscaping hides levee slope. Toe is mostly visible.

Landscaping should be maintained to allow inspection and access to landside slope and toe.

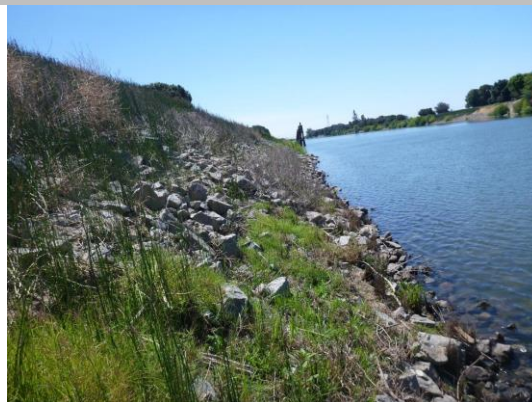
Photo 1 of 3 : FA_2018_RD0551_175_22_20180925_00010.jpg

LM Start	2.71	Rating **	A/W	Issue No.	22
LM End	2.74	Issue Type +	Ma	Location *	
Category	Supplemental			GPS Latitude/Longitude	
				Start	End
Item	2017 Storm Damage			38.301258 °	38.300922 °
				-121.569550 °	-121.569258 °
DWR ID	DWR_RD0551_01_f_2017_22				
Comment Code					
Inspector Comment					
Levee Evaluation Comments					
Description:District Station 142+31 to 143+80, Sec. 08, T. 5 N. R. 4 E., M.D.M. Approximately 149 linear-feet of erosion exists along the waterside slope of the Sacramento River. The erosion exists near the rip rap line about 3/4 of the way down the slope. Some existing rip rap has been pulled off in this section.					
Site ID No:332					
Site Designation:LMA-159					
Repair Type: Erosion					
Rating:Area of Concern					
Field Date:7/13/2017					
Notes: Crown is a paved road. Minor errosion right above and in the top of the rip rap.

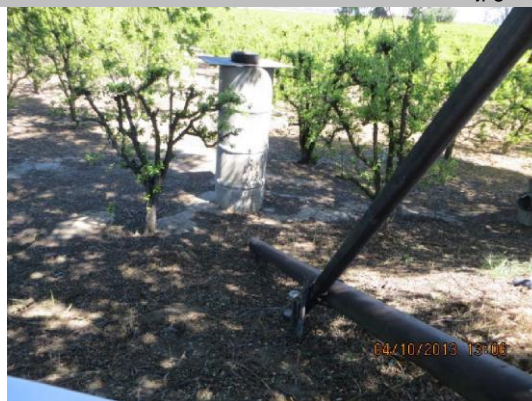
Photo 1 of 2 : UCIP_FA_2018_11803_19261.jpg

48-inch concrete riser on LS toe.

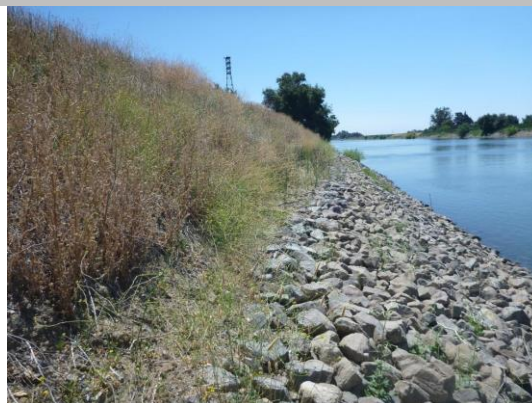
Photo 1 of 3 : FA_2018_RD0551_175_26_20180925_00013.jpg

Comment Code					
Inspector Comment					
Levee Evaluation Comments					
Description:District Station 159+69 to 170+73, Sec. 08, T. 5 N. R. 4 E., M.D.M. Approximately 1,104 linear-feet of erosion and subsequent sloughing exists along the waterside slope of the Sacramento River. The erosion commences approximately halfway down the slope to the rip rap line.					
Site ID No:333					
Site Designation:LMA-160					
Repair Type: Erosion					
Rating:Area of Concern					
Field Date:7/13/2017					
Notes: Crown is a paved road. Thorny veg on upper slope, none in rip rap. Scarps upto 3 ft, mostly smaller, above rip rap. Area of concern because erosion is not too deep into prism and good rip rap protection on lower slope.

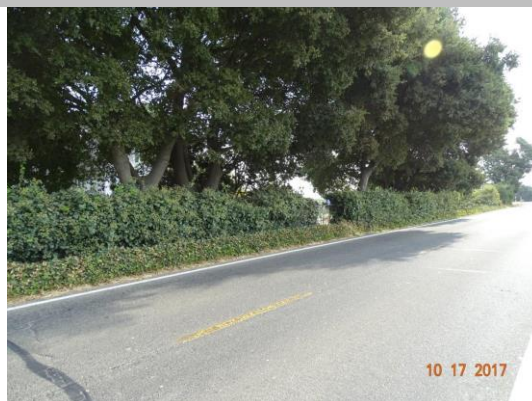
Photo 1 of 1 : FA_2018_RD0551_175_48_20180925_00071.jpg

LM Start	3.81	Rating **	M	Issue No.	48
LM End	3.81	Issue Type +	En	Location *	LS
Category	Earthen Levee			GPS Latitude/Longitude	
				Start	End
Item	Vegetation			38.288783 °	38.288783 °
				-121.557128 °	-121.557128 °
DWR ID	DWR_RD0551_01_f_2017_48				
Comment Code					
V6 : Landscaping					
Inspector Comment					
Landscaping should be maintained to allow inspection and access to landside slope and toe.

Landscaping should be maintained to allow inspection and access to landside slope and toe.

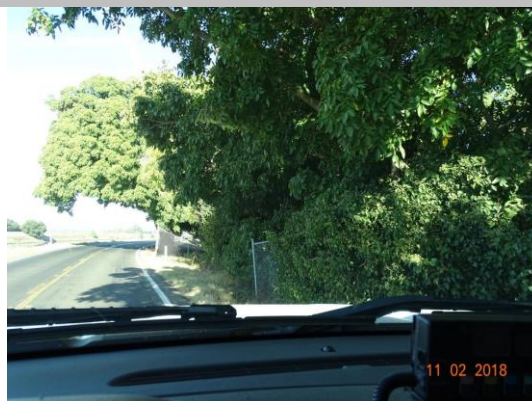
Photo 1 of 1 : FA_2018_RD0551_175_52_20181102_00111.jpg

LM Start	4.22	Rating **	M	Issue No.	52
LM End	4.22	Issue Type +	En	Location *	LS
Category	Earthen Levee			GPS Latitude/Longitude	
				Start	End
Item	Vegetation			38.284400 °	38.284400 °
				-121.552035 °	-121.552035 °
DWR ID	DWR_RD0551_01_f_2018_52				
Comment Code					
V6 : Landscaping					
Inspector Comment

View looking upstream at landscaping on the land side slope (November 2018).

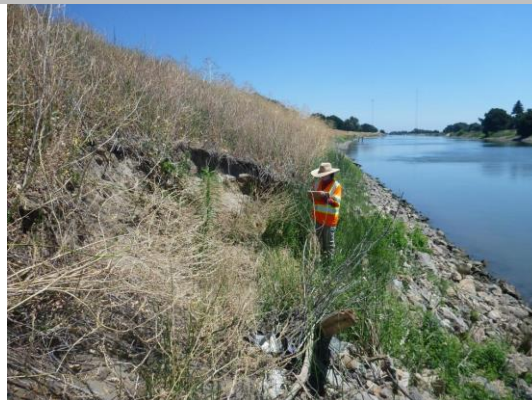
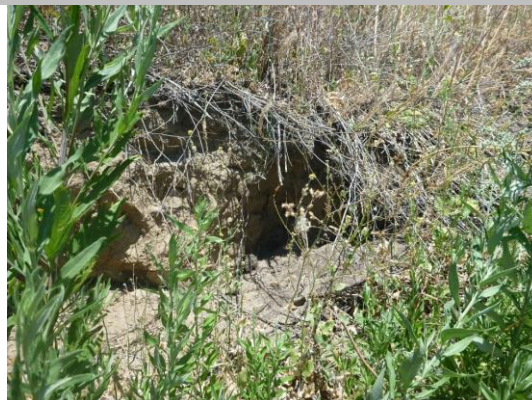
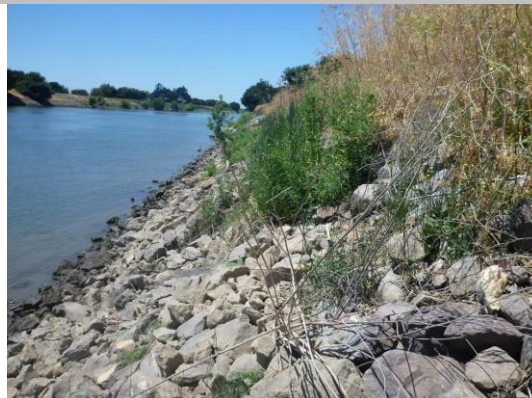
Comment Code					
Inspector Comment					
Levee Evaluation Comments					
Description:District Station 231+12 to 235+26, Sec. 16, T. 5 N. R. 4 E., M.D.M. Approximately 414 linear-feet of erosion and subsequent sloughing exists along the waterside slope of the Sacramento River. The erosion commences approximately 3/4 of the way down the slope to the rip rap line.					
Site ID No:336					
Site Designation:LMA-163					
Repair Type: Erosion					
Rating:Area of Concern					
Field Date:7/13/2017					
Notes: We only saw erosion on about 1½ the length reported by the LMA, but there is another site very close by. Crown is a paved road. Scarps up to 5 ft deep above the rip rap, mostly smaller though so rated this a lower priority site.

Item	2017 Storm Damage		38.282778 °	38.282108 °								
			-121.549531 °	-121.548386 °								
DWR ID	DWR_RD0551_01_f_2017_28											
Comment Code												
Inspector Comment												
<p>Levee Evaluation Comments</p> <p>Description: District Station 231+12 to 235+26, Sec. 16, T. 5 N. R. 4 E., M.D.M. Approximately 414 linear-feet of erosion and subsequent sloughing exists along the waterside slope of the Sacramento River. The erosion commences approximately 3/4 of the way down the slope to the rip rap line.</p> <p>Site ID No: 336</p> <p>Site Designation: LMA-163</p> <p>Repair Type: Erosion</p> <p>Rating: Area of Concern</p> <p>Field Date: 7/13/2017</p> <p>Notes: We only saw erosion on about 1/2 the length reported by the LMA, but there is another site very close by. Crown is a paved road. Scarps up to 5 ft deep above the rip rap, mostly smaller though so rated this a lower priority site.</p>

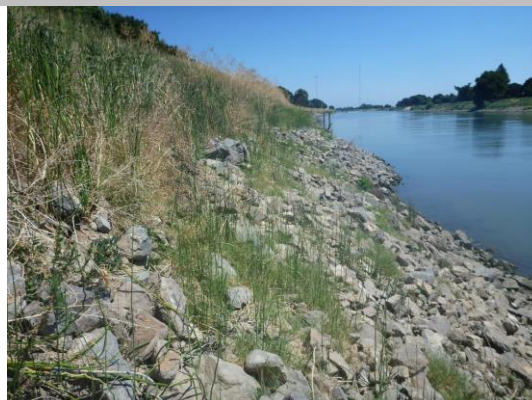
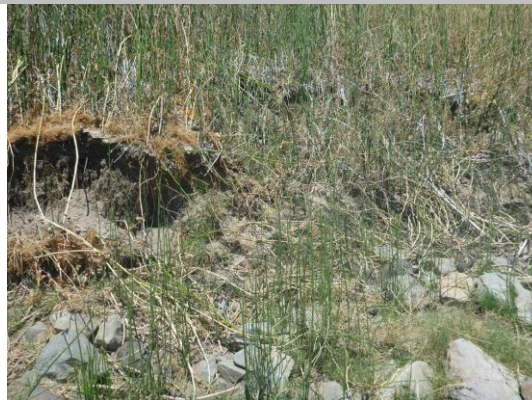
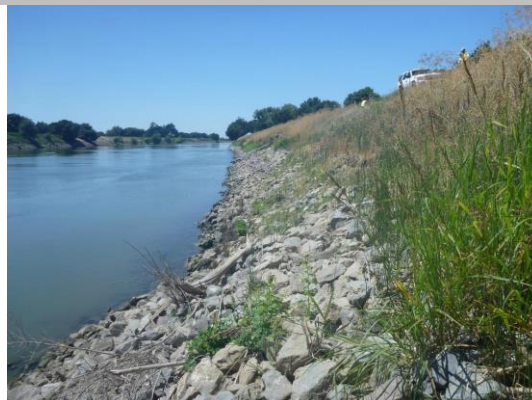
Item	2017 Storm Damage		38.281994 °	38.281653 °								
			-121.548214 °	-121.547700 °								
DWR ID	DWR_RD0551_01_f_2017_29											
Comment Code												
Inspector Comment												
<p>Levee Evaluation Comments</p> <p>Description: District Station 235+90 to 237+83, Sec. 16, T. 5 N. R. 4 E., M.D.M. Approximately 193 linear-feet of erosion exists along the waterside slope of the Sacramento River. The erosion commences approximately halfway down the slope and extends to the rip rap. Some existing rip rap has been pulled off in this section.</p> <p>Site ID No: 337</p> <p>Site Designation: LMA-164</p> <p>Repair Type: Erosion</p> <p>Rating: Area of Concern</p> <p>Field Date: 7/13/2017</p> <p>Notes: Crown is paved road. Veg on slope, not lower bank. Scarps up to 18 in deep above rip rap. Lower priority because erosion is fairly small and rip rap is in good shape through most of the site.</p>

Comment Code						
Inspector Comment						
Levee Evaluation Comments						
Description:District Station 235+90 to 237+83, Sec. 16, T. 5 N. R. 4 E., M.D.M. Approximately 193 linear-feet of erosion exists along the waterside slope of the Sacramento River. The erosion commences approximately halfway down the slope and extends to the rip rap. Some existing rip rap has been pulled off in this section.						
Site ID No:337						
Site Designation:LMA-164						
Repair Type: Erosion						
Rating:Area of Concern						
Field Date:7/13/2017						
Notes: Crown is paved road. Veg on slope, not lower bank. Scarps up to 18 in deep above rip rap. Lower priority because erosion is fairly small and rip rap is in good shape through most of the site.

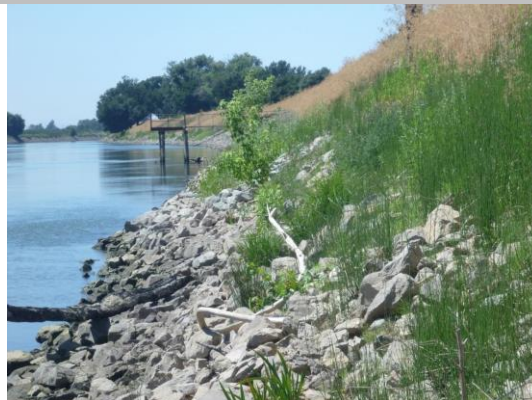
Photo 3 of 3 : FA_2018_RD0551_175_30_20180925_00027.jpg

LM Start	4.67	Rating **	A/W	Issue No.	30 (cont)	
LM End	4.70	Issue Type +	Ma	Location *		
Category	Supplemental			GPS Latitude/Longitude		
				Start	End	
Item	2017 Storm Damage			38.280236 °	38.279892 °	
				-121.545758 °	-121.545314 °	
DWR ID	DWR_RD0551_01_f_2017_30

Comment Code						
Inspector Comment						
Levee Evaluation Comments						
Description: District Station 245+47 to 247+26, Sec. 16, T. 5 N. R. 4 E., M.D.M. Approximately 179 linear-feet of erosion and sloughing exists along the waterside slope of the Sacramento River. The erosion commences approximately halfway down the slope and extends to the rip rap. Some existing rip rap has been pulled off in this section.						
Site ID No: 338						
Site Designation: LMA-165						
Repair Type: Erosion						
Rating: Area of Concern						
Field Date: 7/13/2017						
Notes: Crown is paved road. Scarps up to 7 ft deep, 2 ft typical above the rip rap. Area of concern because the deeper scarp only covered a short distance and was already vegetated so not actively eroding.

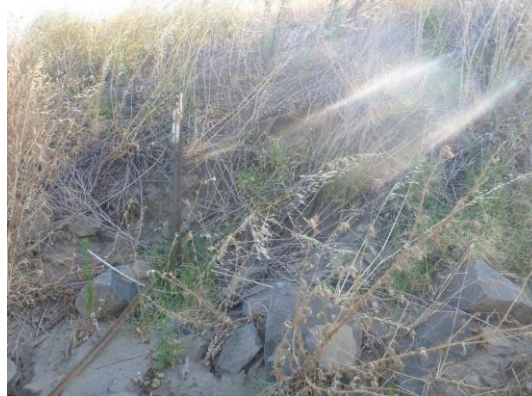
Photo 1 of 3 : FA_2018_RD0551_175_31_20180925_00028.jpg

LM Start	4.92	Rating **	A/W	Issue No.	31
LM End	4.95	Issue Type +	Ma	Location *	
Category	Supplemental			GPS Latitude/Longitude	
				Start	End
Item	2017 Storm Damage			38.277589 °	38.277256 °
				-121.542575 °	-121.542211 °
DWR ID	DWR_RD0551_01_f_2017_31

Comment Code					
Inspector Comment					
Levee Evaluation Comments					
Description:District Station 258+80 to 260+40, Sec. 16, T. 5 N. R. 4 E., M.D.M. Approximately 160 linear-feet of erosion exists along the waterside slope of the Sacramento River. The erosion commences approximately halfway down the slope from the crown and extends to the rip rap. Some existing rip rap has been pulled off in this section.					
Site ID No:339					
Site Designation:LMA-166					
Repair Type: Erosion					
Rating:Area of Concern					
Field Date:7/14/2017					
Notes: crown is a paved road. Scarps of 2.5 ft just above rip rap. Area of concern because erosion is fairly small.

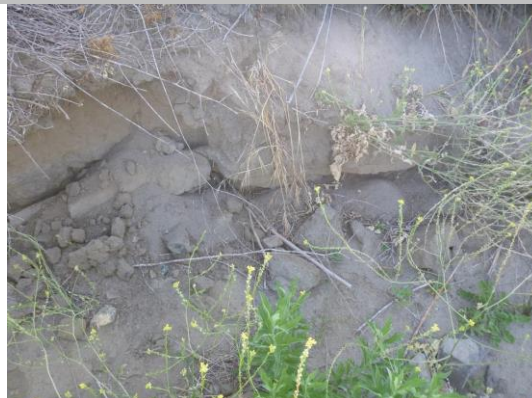
Photo 3 of 3 : FA_2018_RD0551_175_31_20180925_00030.jpg

LM Start	4.92	Rating **	A/W	Issue No.	31 (cont)	
LM End	4.95	Issue Type +	Ma	Location *		
Category	Supplemental			GPS Latitude/Longitude		
				Start	End	
Item	2017 Storm Damage			38.277589 °	38.277256 °	
				-121.542575 °	-121.542211 °	
DWR ID	DWR_RD0551_01_f_2017_31

Comment Code						
Inspector Comment						
Levee Evaluation Comments						
Description:District Station 258+80 to 260+40, Sec. 16, T. 5 N. R. 4 E., M.D.M. Approximately 160 linear-feet of erosion exists along the waterside slope of the Sacramento River. The erosion commences approximately halfway down the slope from the crown and extends to the rip rap. Some existing rip rap has been pulled off in this section.						
Site ID No:339						
Site Designation:LMA-166						
Repair Type: Erosion						
Rating:Area of Concern						
Field Date:7/14/2017						
Notes: crown is a paved road. Scarps of 2.5 ft just above rip rap. Area of concern because erosion is fairly small.

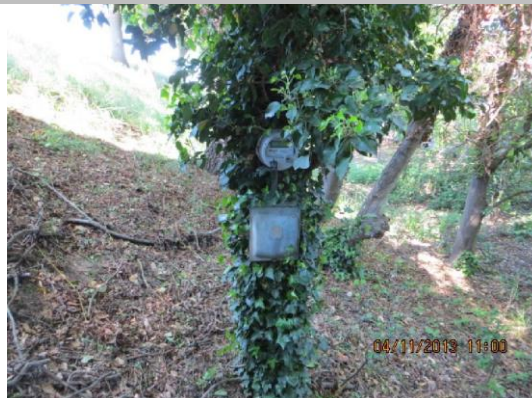
Photo 2 of 3 : UCIP_FA_2018_12105_19648.jpg

Comment Code						
Inspector Comment						
FS_ID:12105 DS_ID:22022 EP_NO: 11125 Repair Type: Non-Urgent Crossing Status: Found UCIP Comments: Pumphouse has been removed from pump and pump is in disrepair. Pipe at LS toe is sleeved or has been replaced with a 6-inch PVC pipe. This pump appears abandoned and should be done so properly. FIELD_STRUCT_DESC: 6-inch irrigation pipe of an unknown material through the levee, 6.5 feet below the crown. Pump and slide gate on the waterside (WS) slope. 1-inch electrical conduit at the same location with service pole at the landside (LS) toe. 4-foot by 6-foot concrete distribution box at the LS toe. (Automatic Board Order (ABO) issued as Permit No. 11125, 1975 - William H. and Evelyn J. Cortopassi). [Additional Reference(s): DWR Levee Log, 2005. USACE Sacramento O&M Manual 111, May 1959, (RM 29.71)]. FS Date: 4/11/2013

Meter on pole at LS toe.

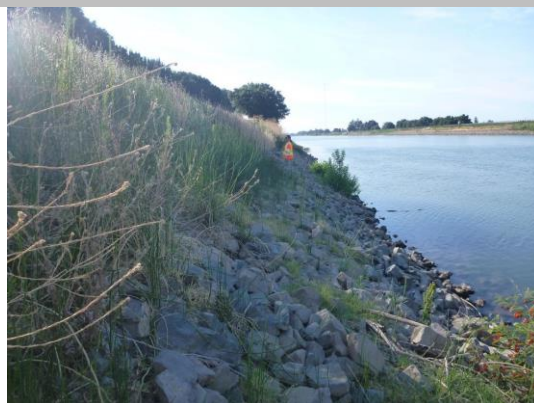
Photo 1 of 3 : FA_2018_RD0551_175_32_20180925_00031.jpg

Item	2017 Storm Damage		38.276072 °	38.275761 °								
			-121.540869 °	-121.540497 °								
DWR ID	DWR_RD0551_01_f_2017_32											
Comment Code												
Inspector Comment												
<p>Levee Evaluation Comments</p> <p>Description: District Station 266+16 to 267+71, Sec. 21, T. 5 N. R. 4 E., M.D.M. Approximately 155 linear-feet of erosion and sloughing exists along the waterside slope of the Sacramento River. The erosion commences approximately 3/4 of the way down the slope from the crown and extends into the rip rap. Some existing rip rap has been pulled off in this section.</p> <p>Site ID No: 340</p> <p>Site Designation: LMA-167</p> <p>Repair Type: Erosion</p> <p>Rating: Area of Concern</p> <p>Field Date: 7/14/2017</p> <p>Notes: Crown is a paved road. There is a private boat dock in the middle of the site. Some exposed filter fabric. On the upstream side erosion is above the rip rap and on the downstream side it is within the rip rap. Scarps are 2-3 ft deep. Area of concern because erosion is not very deep into prism.</p>

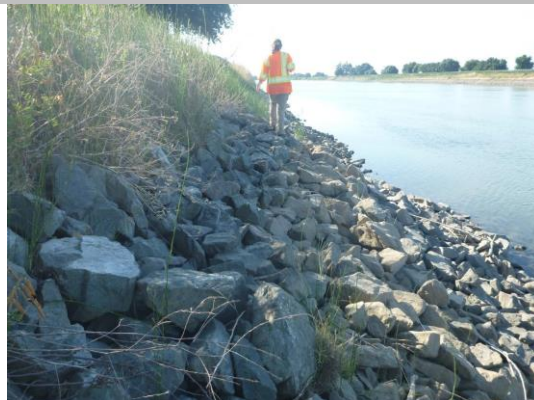
Photo 1 of 3 : FA_2018_RD0551_175_33_20180925_00034.jpg

LM Start	5.12	Rating **	A/W	Issue No.	33
LM End	5.16	Issue Type +	Ma	Location *	
Category	Supplemental			GPS Latitude/Longitude	
				Start	End
Item	2017 Storm Damage		38.275442°	38.274997°	
			-121.540094°	-121.539514°	
DWR ID	DWR_RD0551_01_f_2017_33

Comment Code					
Inspector Comment					
Levee Evaluation Comments					
Description: District Station 269+37 to 271+66, Sec. 21, T. 5 N. R. 4 E., M.D.M. Approximately 229 linear-feet of erosion and sloughing exists along the waterside slope of the Sacramento River. The erosion commences approximately 3/4 of the way down the slope from the crown and extends to the rip rap.					
Site ID No: 341					
Site Designation: LMA-168					
Repair Type: Erosion					
Rating: Area of Concern					
Field Date: 7/14/2017					
Notes: crown is a paved road. Scarps upto 4-5 ft, but 18 inches for most of the length. Large tree within site. Area of concern because deeper erosion is only present for a short distance.

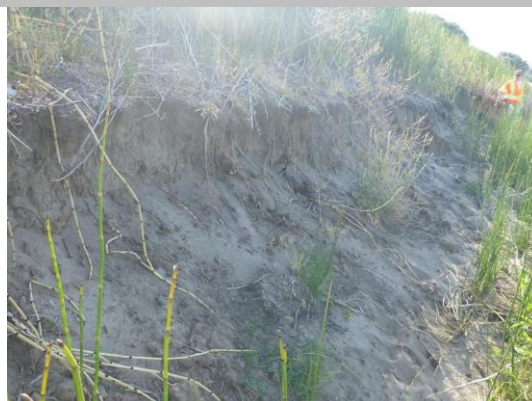
Photo 2 of 3 : FA_2018_RD0551_175_34_20180925_00038.jpg

Comment Code					
Inspector Comment					
<p>Levee Evaluation Comments</p> <p>Description: District Station 273+82 to 278+08, Sec. 21 and 22, T. 5 N. R. 4 E., M.D.M. Approximately 426 linear-feet of erosion exists along the waterside slope of the Sacramento River. The erosion commences approximately halfway down the slope and extends to the rip rap. Some existing rip rap has been pulled off in this section.</p> <p>Site ID No: 342</p> <p>Site Designation: LMA-169</p> <p>Repair Type: Erosion</p> <p>Rating: Serious</p> <p>Field Date: 7/14/2017</p> <p>Notes: there is a 7 ft scarp that extends for 40-60 ft in very sandy soil, scarps are 2-4 ft the rest of the length. Worst site in this RD so far. Serious because of the length of this deeper scarp and the weak soil here. Crown is a paved road.</p>

LM Start	5.20	Rating **	M	Issue No.	34 (cont)
LM End	5.28	Issue Type +	Ma	Location *	
Category	Supplemental			GPS Latitude/Longitude	
				Start	End
Item	2017 Storm Damage			38.274592 °	38.273800 °
				-121.538958 °	-121.537869 °
DWR ID	DWR_RD0551_01_f_2017_34

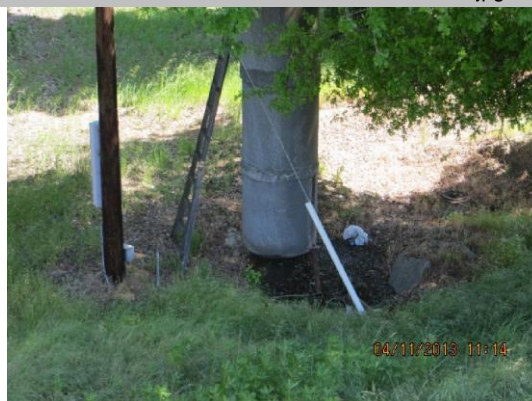
Photo 1 of 3 : UCIP_FA_2018_26875_49602.jpg

Comment Code					
Inspector Comment					
FS_ID:26875 DS_ID:22023 EP_NO: 11131 Repair Type: Non-Urgent Crossing Status: Found UCIP Comments: Based on District notes from January 15, 2014, pump discharge pipe has been repaired. Corrosion holes in pipe at LS toe good indicator that pipe is failing internally. Pipe should be examined internally for damage (video inspect).: As of 12/12/2013 the District discussed with farmer tenant what needed to be done, and the tenant informed the District that they would address the repairs.: As of 12/17/2013 District submitted letter to landowner explaining UCIP report details including photos of the pipe problems FIELD_STRUCT_DESC: 10-inch irrigation pipe of an unknown material through the levee, 7.7 feet below the crown. Pump and slide gate on a concrete pad on the waterside (WS) slope. Siphon breaker in a 24-inch corrugated metal pipe (CMP) riser on the landside (LS) slope. Concrete riser and power pole with panel box on the LS toe. (Automatic Board Order (ABO) issued as Permit No. 11131, 1975 - Helen Crofton and Sloane Latimer). [Additional Reference(s): DWR Levee Log, 2005. USACE Sacramento O&M Manual 111, May 1959, (RM 29.52) (9-inch pipe listed)]. FS Date: 1/15/2014

Concrete standpipe, JP and meter, and 4-inch steel pipe visible at LS toe.

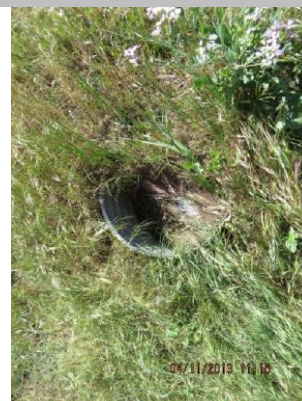
Photo 3 of 3 : UCIP_FA_2018_26875_49600.jpg

Comment Code						
Inspector Comment						
FS_ID:26875 DS_ID:22023 EP_NO: 11131 Repair Type: Non-Urgent Crossing Status: Found UCIP Comments: Based on District notes from January 15, 2014, pump discharge pipe has been repaired. Corrosion holes in pipe at LS toe good indicator that pipe is failing internally. Pipe should be examined internally for damage (video inspect).: As of 12/12/2013 the District discussed with farmer tenant what needed to be done, and the tenant informed the District that they would address the repairs.: As of 12/17/2013 District submitted letter to landowner explaining UCIP report details including photos of the pipe problems FIELD_STRUCT_DESC: 10-inch irrigation pipe of an unknown material through the levee, 7.7 feet below the crown. Pump and slide gate on a concrete pad on the waterside (WS) slope. Siphon breaker in a 24-inch corrugated metal pipe (CMP) riser on the landside (LS) slope. Concrete riser and power pole with panel box on the LS toe. (Automatic Board Order (ABO) issued as Permit No. 11131, 1975 - Helen Crofton and Sloane Latimer). [Additional Reference(s): DWR Levee Log, 2005. USACE Sacramento O&M Manual 111, May 1959, (RM 29.52) (9-inch pipe listed)]. FS Date: 1/15/2014

Siphon breaker in 24-inch CMP riser on LS slope.

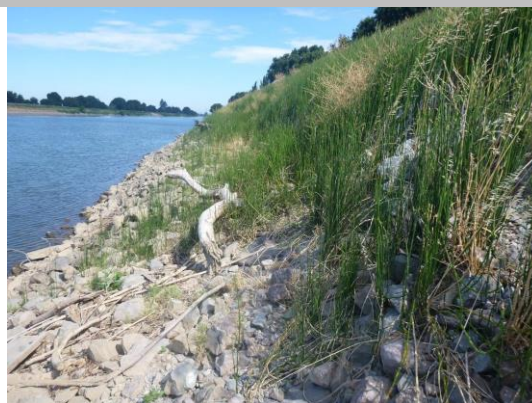
Photo 3 of 3 : FA_2018_RD0551_175_35_20180925_00042.jpg

LM Start	5.38	Rating **	A/W	Issue No.	35 (cont)
LM End	5.42	Issue Type +	Ma	Location *	
Category	Supplemental			GPS Latitude/Longitude	
				Start	End
Item	2017 Storm Damage			38.272867°	38.272411°
				-121.536597°	-121.535983°
DWR ID	DWR_RD0551_01_f_2017_35

Comment Code					
Inspector Comment					
<p>Levee Evaluation Comments</p> <p>Description: District Station 283+08 to 285+49, Sec. 22, T. 5 N. R. 4 E., M.D.M. Approximately 241 linear-feet of erosion and sloughing exists along the waterside slope of the Sacramento River. The erosion commences approximately 3/4 of the way down the slope and extends to the rip rap. Some existing rip rap has been pulled off in this section.</p> <p>Site ID No: 343</p> <p>Site Designation: LMA-170</p> <p>Repair Type: Erosion</p> <p>Rating: Area of Concern</p> <p>Field Date: 7/14/2017</p> <p>Notes: Crown is a paved road. Scarps above rip rap 2-4 ft deep, but not continuous through whole site. Area of concern because erosion is not very deep into prism and is not continuous throughout site.</p>

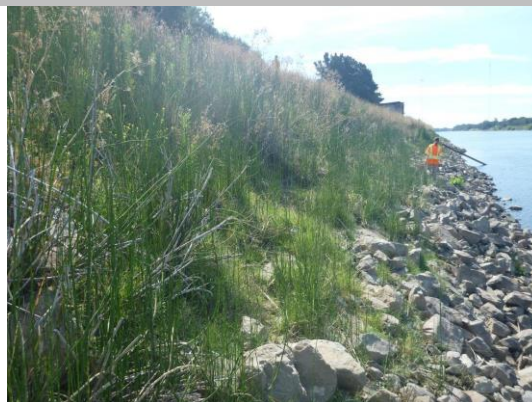
Photo 1 of 3 : FA_2018_RD0551_175_36_20180925_00043.jpg

LM Start	5.52	Rating **	A/W	Issue No.	36
LM End	5.54	Issue Type +	Ma	Location *	
Category	Supplemental			GPS Latitude/Longitude	
				Start	End
Item	2017 Storm Damage			38.271406°	38.271208°
				-121.534644°	-121.534381°
DWR ID	DWR_RD0551_01_f_2017_36

Comment Code					
Inspector Comment					
<p>Levee Evaluation Comments</p> <p>Description: District Station 290+80 to 291+85, Sec. 22, T. 5 N. R. 4 E., M.D.M. Approximately 105 linear-feet of erosion and sloughing exists along the waterside slope of the Sacramento River. The erosion commences approximately 3/4 of the way down the slope and extends into the rip rap. Some existing rip rap has been pulled off in this section.</p> <p>Site ID No: 344</p> <p>Site Designation: LMA-171</p> <p>Repair Type: Erosion</p> <p>Rating: Area of Concern</p> <p>Field Date: 7/14/2017</p> <p>Notes: Crown is a paved road. Erosion scarps 1-4 ft deep just above rip rap. Area of concern because erosion is not very deep into prism.</p>

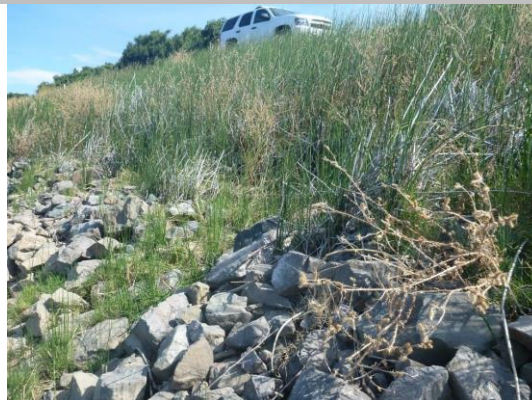
Photo 2 of 3 : FA_2018_RD0551_175_36_20180925_00044.jpg

LM Start	5.52	Rating **	A/W	Issue No.	36 (cont)	
LM End	5.54	Issue Type +	Ma	Location *		
Category	Supplemental			GPS Latitude/Longitude		
				Start	End	
Item	2017 Storm Damage			38.271406 °	38.271208 °	
				-121.534644 °	-121.534381 °	
DWR ID	DWR_RD0551_01_f _ 2017_36

Comment Code						
Inspector Comment						
Levee Evaluation Comments						
Description:District Station 290+80 to 291+85, Sec. 22, T. 5 N. R. 4 E., M.D.M. Approximately 105 linear-feet of erosion and sloughing exists along the waterside slope of the Sacramento River. The erosion commences approximately 3/4 of the way down the slope and extends into the rip rap. Some existing rip rap has been pulled off in this section.						
Site ID No:344						
Site Designation:LMA-171						
Repair Type: Erosion						
Rating:Area of Concern						
Field Date:7/14/2017						
Notes: Crown is a paved road. Erosion scarps 1-4 ft deep just above rip rap. Area of concern because erosion is not very deep into prism.

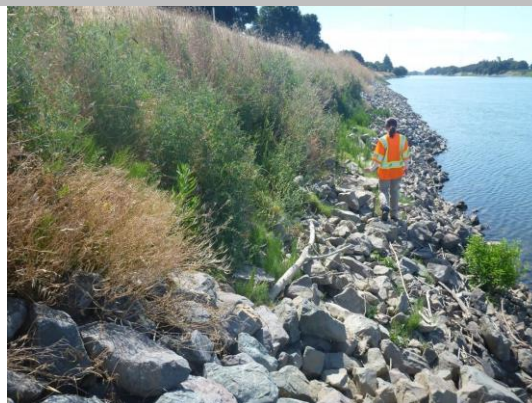
Photo 1 of 3 : FA_2018_RD0551_175_37_20180925_00046.jpg

LM Start	5.77	Rating **	A/W	Issue No.	37
LM End	5.79	Issue Type +	Ma	Location *	
Category	Supplemental			GPS Latitude/Longitude	
				Start	End
Item	2017 Storm Damage			38.269025 °	38.268814 °
				-121.531361 °	-121.531058 °
DWR ID	DWR_RD0551_01_f_2017_37

Comment Code					
Inspector Comment					
Levee Evaluation Comments					
Description:District Station 303+60 to 304+75, Sec. 22, T. 5 N. R. 4 E., M.D.M. Approximately 115 linear-feet of erosion and sloughing exists along the waterside slope of the Sacramento River. The erosion occurs just above the rip rap line. Some existing rip rap has been pulled off in this section.					
Site ID No:345					
Site Designation:LMA-172					
Repair Type: Erosion					
Rating:Area of Concern					
Field Date:7/14/2017					
Notes: Crown is a paved road. 4 ft deep scarp above the rip rap. Area of concern because erosion is not very deep into prism and there was lots of vegetation growing in the damaged area indicating it may be an older issue.

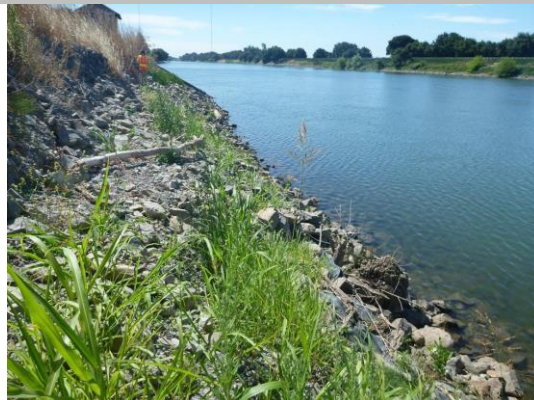
Photo 1 of 3 : FA_2018_RD0551_175_38_20180925_00049.jpg

LM Start	5.85	Rating **	M	Issue No.	38
LM End	5.86	Issue Type +	Ma	Location *	
Category	Supplemental			GPS Latitude/Longitude	
				Start	End
Item	2017 Storm Damage			38.268244 °	38.268139 °
				-121.530233 °	-121.530075 °
DWR ID	DWR_RD0551_01_f_2017_38

Comment Code					
Inspector Comment					
Levee Evaluation Comments					
Description:District Station 307+90 to 305+49, Sec. 22, T. 5 N. R. 4 E., M.D.M. Approximately 59 linear-feet of erosion exists along the waterside slope of the Sacramento River. The erosion occurs approximately halfway down the slope within the rip rapped area. Existing rip rap has been pulled off in this section.					
Site ID No:346					
Site Designation:LMA-173					
Repair Type: Erosion					
Rating:Area of Concern					
Field Date:7/14/2017					
Notes: Crown is a paved road. Erosion scarps 4-6 ft high, but soil is more stable than other nearby sites with large gravel in silt or clay so we rated this as an area of concern.

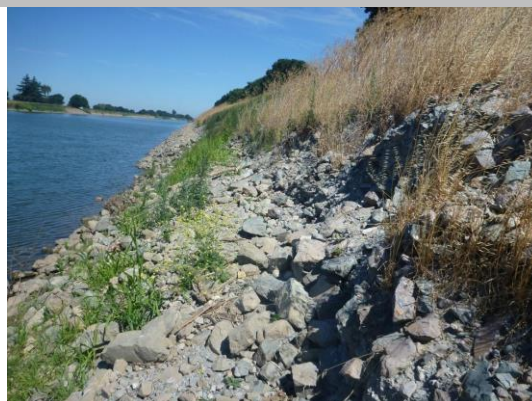
Photo 3 of 3 : FA_2018_RD0551_175_38_20180925_00051.jpg

LM Start	5.85	Rating **	M	Issue No.	38 (cont)
LM End	5.86	Issue Type +	Ma	Location *	
Category	Supplemental			GPS Latitude/Longitude	
				Start	End
Item	2017 Storm Damage			38.268244 °	38.268139 °
				-121.530233 °	-121.530075 °
DWR ID	DWR_RD0551_01_f_2017_38

Comment Code					
Inspector Comment					
<p>Levee Evaluation Comments</p> <p>Description: District Station 307+90 to 305+49, Sec. 22, T. 5 N. R. 4 E., M.D.M. Approximately 59 linear-feet of erosion exists along the waterside slope of the Sacramento River. The erosion occurs approximately halfway down the slope within the rip rapped area. Existing rip rap has been pulled off in this section.</p> <p>Site ID No: 346</p> <p>Site Designation: LMA-173</p> <p>Repair Type: Erosion</p> <p>Rating: Area of Concern</p> <p>Field Date: 7/14/2017</p> <p>Notes: Crown is a paved road. Erosion scarps 4-6 ft high, but soil is more stable than other nearby sites with large gravel in silt or clay so we rated this as an area of concern.</p>

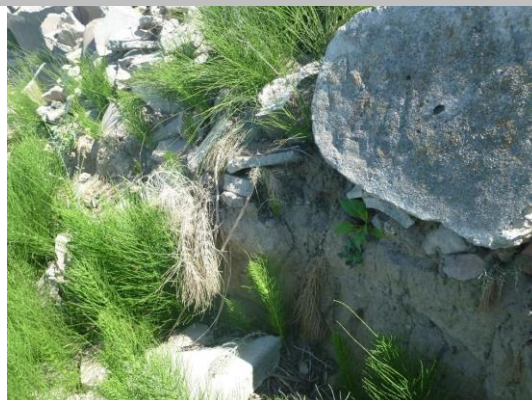
Photo 1 of 3 : FA_2018_RD0551_175_39_20180925_00052.jpg

LM Start	5.88	Rating **	M	Issue No.	39
LM End	5.90	Issue Type +	Ma	Location *	
Category	Supplemental			GPS Latitude/Longitude	
				Start	End
Item	2017 Storm Damage			38.267989 °	38.267775 °
				-121.529853 °	-121.529533 °
DWR ID	DWR_RD0551_01_f_2017_39

Comment Code					
Inspector Comment					
<p>Levee Evaluation Comments</p> <p>Description: District Station 309+33 to 310+53, Sec. 22, T. 5 N. R. 4 E., M.D.M. Approximately 120 linear-feet of erosion and sloughing exists along the waterside slope of the Sacramento River. The erosion commences approximately halfway down the slope, extending into the rip rap. Some existing rip rap has been pulled off in this section.</p> <p>Site ID No: 347</p> <p>Site Designation: LMA-174</p> <p>Repair Type: Erosion</p> <p>Rating: Area of Concern</p> <p>Field Date: 7/14/2017</p> <p>Notes: Crown is a paved road. Pump house in the middle of this site. 18 inch scarps in and just above top of rip rap. Area of concern because erosion is not very deep into prism.</p>

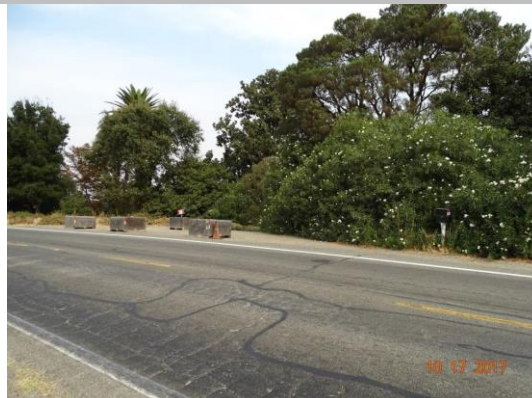
Photo 1 of 1 : FA_2018_RD0551_175_50_20180925_00073.jpg

LM Start	5.90	Rating **	M	Issue No.	50
LM End	5.90	Issue Type +	En	Location *	LS
Category	Earthen Levee			GPS Latitude/Longitude	
				Start	End
Item	Vegetation			38.267833°	38.267833°
				-121.529438°	-121.529438°
DWR ID	DWR_RD0551_01_f_2017_50				
Comment Code					
V6 : Landscaping					
Inspector Comment					
Trim/thin oleanders and ivy to allow inspection of levee slope.

Landscaping should be maintained to allow inspection and access to landside slope and toe.

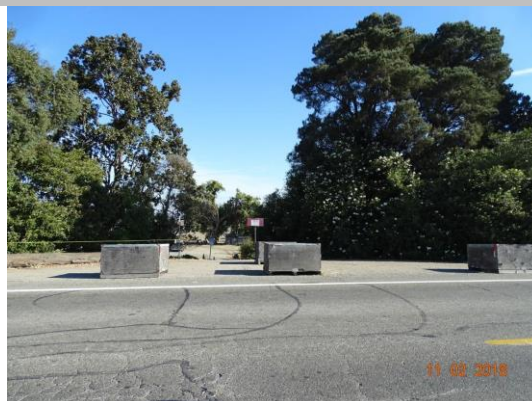
Photo 1 of 1 : FA_2018_RD0551_175_59_20181102_00115.jpg

LM Start	5.90	Rating **	A/W	Issue No.	59
LM End	5.90	Issue Type +	En	Location *	LS
Category	Earthen Levee			GPS Latitude/Longitude	
				Start	End
Item	Encroachments			38.267757 °	38.267757 °
				-121.529443 °	-121.529443 °
DWR ID	DWR_RD0551_01_f_2018_59				
Comment Code					
MA : Material					
Inspector Comment					
Boxes on landside shoulder inhibiting access down the levee

View of boxes on the land side shoulder that landowner placed to block traffic from using driveway (November 2018).

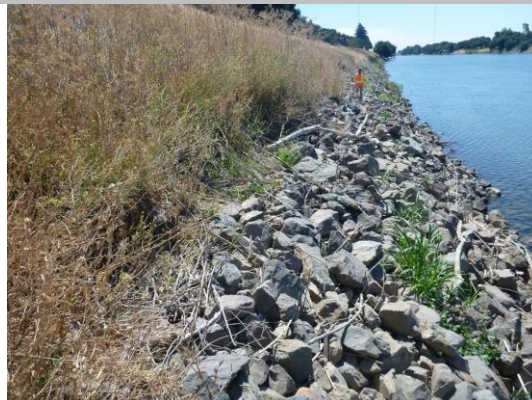
Photo 1 of 3 : FA_2018_RD0551_175_40_20180925_00055.jpg

LM Start	5.95	Rating **	M	Issue No.	40
LM End	5.97	Issue Type +	Ma	Location *	
Category	Supplemental			GPS Latitude/Longitude	
				Start	End
Item	2017 Storm Damage			38.267286 °	38.267094 °
				-121.528886 °	-121.528642 °
DWR ID	DWR_RD0551_01_f _ 2017_40

Comment Code					
Inspector Comment					
Levee Evaluation Comments					
Description:District Station 313+15 to 314+15, Sec. 22, T. 5 N. R. 4 E., M.D.M. Approximately 100 linear-feet of erosion and sloughing exists along the waterside slope of the Sacramento River. The erosion commences approximately halfway down the slope and extends into the rip rap. Some existing rip rap has been pulled off in this section.					
Site ID No:349					
Site Designation:LMA-176					
Repair Type: Erosion					
Rating:Area of Concern					
Field Date:7/14/2017					
Notes: 18 in to 3 ft vertical scarps just above rip rap. Crown is a paved road. Area of concern because erosion is not very deep into prism.

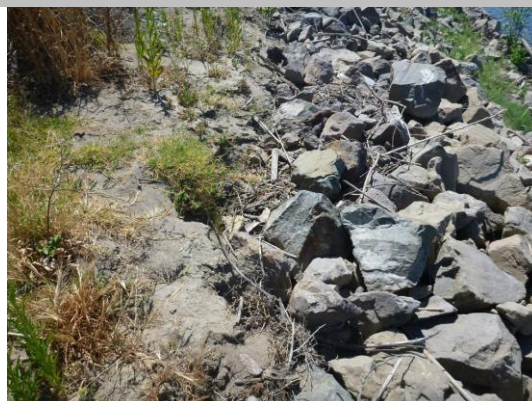
Photo 3 of 3 : FA_2018_RD0551_175_40_20180925_00057.jpg

Item	2017 Storm Damage		38.267286°	38.267094°								
			-121.528886°	-121.528642°								
DWR ID	DWR_RD0551_01_f_2017_40											
Comment Code												
Inspector Comment												
<p>Levee Evaluation Comments</p> <p>Description: District Station 313+15 to 314+15, Sec. 22, T. 5 N. R. 4 E., M.D.M. Approximately 100 linear-feet of erosion and sloughing exists along the waterside slope of the Sacramento River. The erosion commences approximately halfway down the slope and extends into the rip rap. Some existing rip rap has been pulled off in this section.</p> <p>Site ID No: 349</p> <p>Site Designation: LMA-176</p> <p>Repair Type: Erosion</p> <p>Rating: Area of Concern</p> <p>Field Date: 7/14/2017</p> <p>Notes: 18 in to 3 ft vertical scarps just above rip rap. Crown is a paved road. Area of concern because erosion is not very deep into prism.</p>

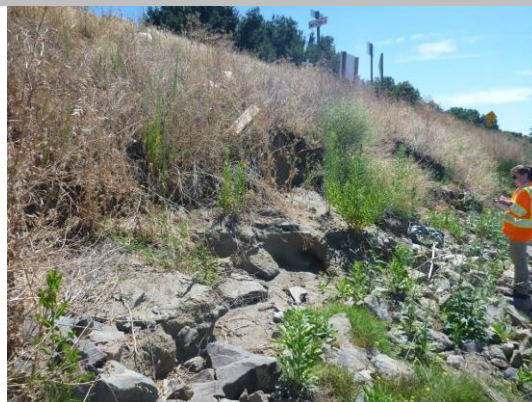
Photo 1 of 3 : FA_2018_RD0551_175_41_20180925_00058.jpg

Item	2017 Storm Damage		38.266686°	38.265917°								
			-121.528128°	-121.527194°								
DWR ID	DWR_RD0551_01_f_2017_41											
Comment Code												
Inspector Comment												
<p>Levee Evaluation Comments</p> <p>Description: District Station 316+24 to 320+12, Sec. 22, T. 5 N. R. 4 E., M.D.M. Approximately 388 linear-feet of erosion exists along the waterside slope of the Sacramento River. The erosion commences approximately halfway down the slope and extends into the rip rap. Some existing rip rap has been pulled off in this section.</p> <p>Site ID No: 350</p> <p>Site Designation: LMA-177</p> <p>Repair Type: Erosion</p> <p>Rating: Area of Concern</p> <p>Field Date: 7/14/2017</p> <p>Notes: Crown is paved road. Erosion scarps between 1-6 ft deep. Area of concern because the deeper erosion only extended for a short distance.</p>

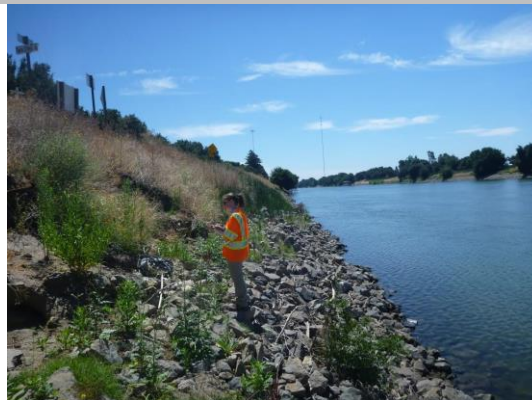
Photo 2 of 3 : FA_2018_RD0551_175_41_20180925_00059.jpg

Comment Code						
Inspector Comment						
Levee Evaluation Comments						
Description: District Station 316+24 to 320+12, Sec. 22, T. 5 N. R. 4 E., M.D.M. Approximately 388 linear-feet of erosion exists along the waterside slope of the Sacramento River. The erosion commences approximately halfway down the slope and extends into the rip rap. Some existing rip rap has been pulled off in this section.						
Site ID No:350						
Site Designation:LMA-177						
Repair Type: Erosion						
Rating:Area of Concern						
Field Date:7/14/2017						
Notes: Crown is aved road. Erosion scarps between 1-6 ft deep. Area of concern because the deeper erosion only extended for a short distance.

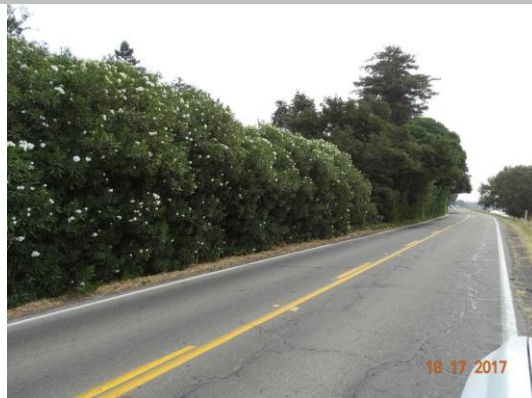
Photo 1 of 1 : FA_2018_RD0551_175_51_20180925_00074.jpg

LM Start	6.19	Rating **	U	Issue No.	51
LM End	6.26	Issue Type +	En	Location *	LS
Category	Earthen Levee			GPS Latitude/Longitude	
				Start	End
Item	Vegetation			38.264814 °	38.264112 °
				-121.525728 °	-121.524845 °
DWR ID	DWR_RD0551_01_f_2017_51				
Comment Code					
V6 : Landscaping					
Inspector Comment					
Landscaping should be maintained to allow inspection and access to landside slope and toe.

Landscaping should be maintained to allow inspection and access to landside slope and toe.

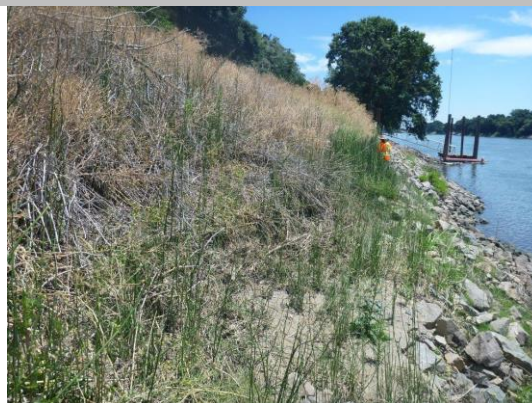
Photo 1 of 3 : FA_2018_RD0551_175_42_20180925_00061.jpg

Comment Code					
Inspector Comment					
Levee Evaluation Comments					
Description:District Station 327+45 to 328+45, Sec. 22, T. 5 N. R. 4 E., M.D.M. Approximately 100 linear-feet of erosion and sloughing exists along the waterside slope of the Sacramento River. The erosion commences approximately halfway down the slope and extends into the rip rap. Existing rip rap has been pulled off in this section.					
Site ID No:351					
Site Designation:LMA-178					
Repair Type: Erosion					
Rating:Serious					
Field Date:7/14/2017					
Notes: Crown is a paved road. Scarps above rip rap are about 7 ft deep. Rated this serious because erosion scarps are pretty deep, sandy material, steep slope, the rip rap is in poor condition and high traffic on the levee road.

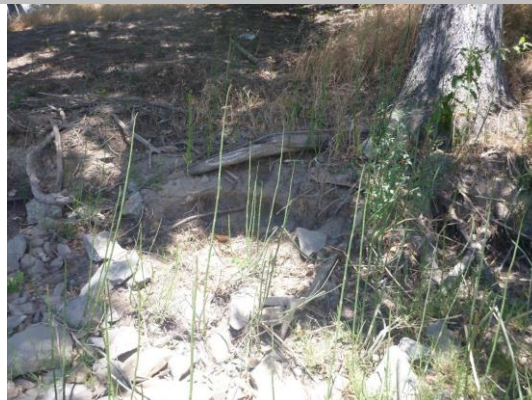
Photo 1 of 3 : FA_2018_RD0551_175_43_20180925_00064.jpg

Item	2017 Storm Damage		38.263906°	38.263756°								
			-121.524778°	-121.524575°								
DWR ID	DWR_RD0551_01_f_2017_43											
Comment Code												
Inspector Comment												
<p>Levee Evaluation Comments</p> <p>Description: District Station 330+19 to 330+99, Sec. 22, T. 5 N. R. 4 E., M.D.M. Approximately 80 linear-feet of erosion/sloughing and minor slippage exists along the waterside slope of the Sacramento River. The erosion/sloughing commences approximately halfway down the slope and extends into the rip rap. Existing rip rap has been pulled off in this section.</p> <p>Site ID No: 352</p> <p>Site Designation: LMA-179</p> <p>Repair Type: Erosion</p> <p>Rating: Area of Concern</p> <p>Field Date: 7/14/2017</p> <p>Notes: Crown is a paved road. Erosion scarps are only 1 ft deep. Area of concern because erosion is not very deep into prism.</p>

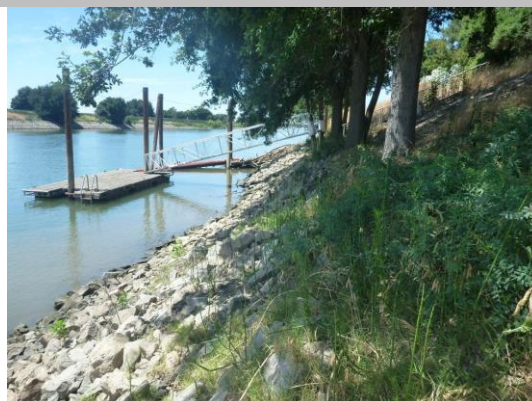
Photo 3 of 3 : FA_2018_RD0551_175_43_20180925_00066.jpg

Comment Code						
Inspector Comment						
Levee Evaluation Comments						
Description:District Station 330+19 to 330+99, Sec. 22, T. 5 N. R. 4 E., M.D.M. Approximately 80 linear-feet of erosion/sloughing and minor slippage exists along the waterside slope of the Sacramento River. The erosion/sloughing commences approximately halfway down the slope and extends into the rip rap. Existing rip rap has been pulled off in this section.						
Site ID No:352						
Site Designation:LMA-179						
Repair Type: Erosion						
Rating:Area of Concern						
Field Date:7/14/2017						
Notes: Crown is a paved road. Erosion scarps are only 1 ft deep. Area of concern because erosion is not very deep into prism.
